Material evidence

Simulations have helped understanding of the performance of cob walls during flooding, as **Alan Foster**, **Gabriella Medero** and **Tom Morton** explain

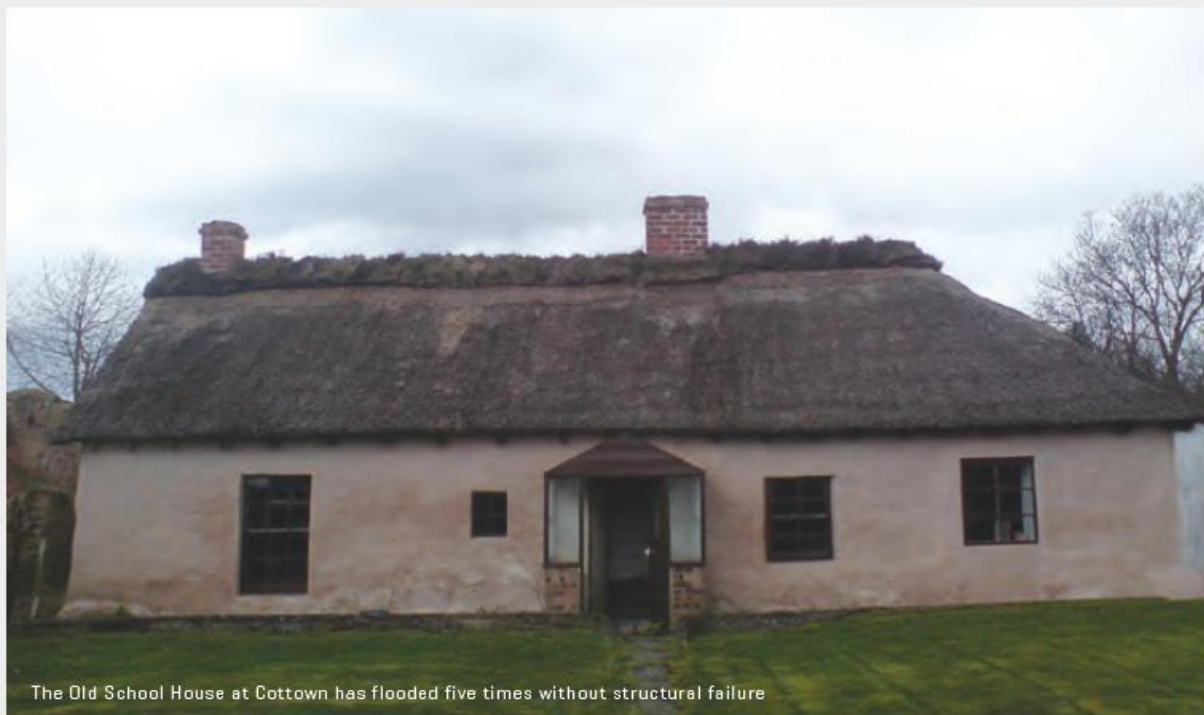
Take the example of the Old School House at Cottown, Perthshire, built around 1760 of cob – one of the most frequently occurring types of earth construction. The building had been flooded five times in recent years, but while the submerged regions exhibited undercutting and loss of earth materials from the wall faces, there was no structural failure. In a bid to gather data, a study was carried out at Heriot-Watt University that

The Old School House at Cottown has flooded five times without structural failure

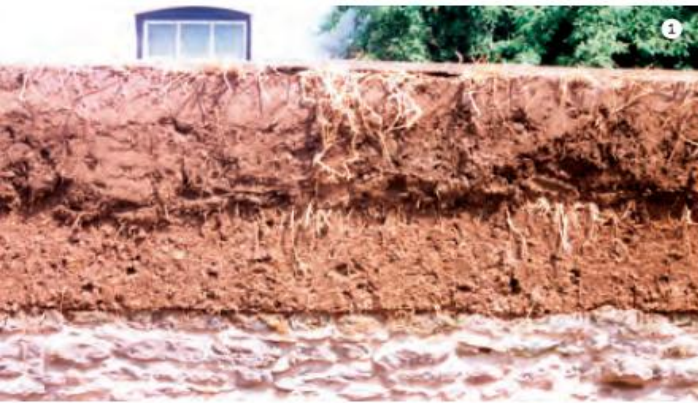
Cob construction relies on a suitable base made of rubble stone work built in lime mortar, on which are placed suitably prepared earth materials. Balancing the amount of clays and aggregates is essential for most types of earth building, and the clay component can vary from 10% to 40%. Additionally, straw is an essential component, increasing the tensile strength and reducing cracking. The cob material is generally lifted in place using a pitch fork, and built up in non-shuttered (unconfined) working lifts 500mm in height. Compaction is achieved by the operative's feet pressing the wall head then the use of a wooden plank dropped onto the surface, creating a level plane for the next lift. The sides are then 'pared', cut to a relatively perpendicular plane, before final consolidation using a 'mud hammer'.

- 1 Cob wall construction comprises a rubble base topped with compacted and parged clay/straw mix
- 2 Cob sample at 40 x compaction
- 3 A thin surface layer of water has coated the sample with menisci
