Forster, AM & Medero, GM 2014, 'Material evidence: Simulations have helped understanding of the performance of cob walls during flooding' *Building Surveying Journal*, pp. 31-33.

# Material evidence

Simulations have helped understanding of the performance of cob walls during flooding, as **Alan Foster**, **Gabriella Medero** and **Tom Morton** explain

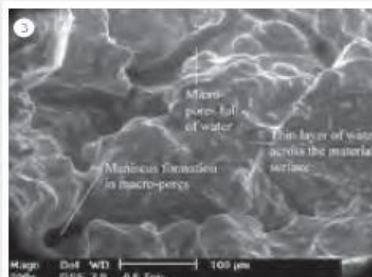
[Photo 3](#) illustrates a thin layer of water that has coated the sample. The development of menisci between the clay/aggregate particles can be seen in several locations. The micro-pore structure is apparently full of water, while the macro-pores are still unsaturated. The clay particles and siliceous aggregates are hydrophilic in nature.

- 1 Cob wall construction comprises a rubble base topped with compacted and parged clay/straw mix
- 2 Cob sample at 40 x compaction
- 3 A thin surface layer of water has coated the sample with menisci
