Case study: drainage and foot-and-mouth

Grant Wright

Drainage and Water Supply Group, School of Built Environment, Heriot-Watt University, Edinburgh, Scotland

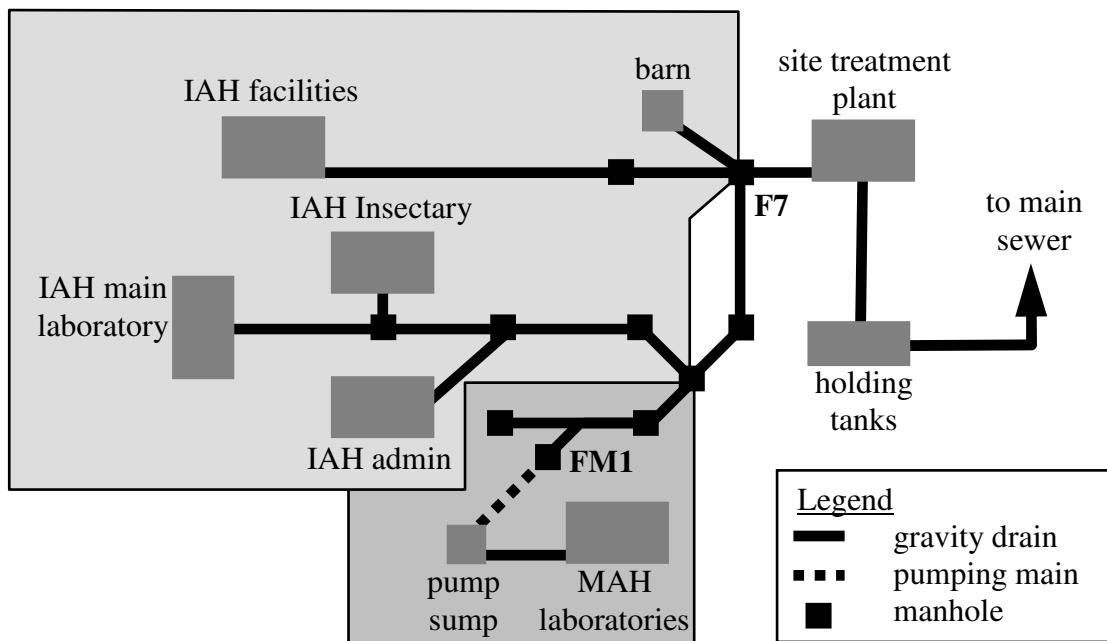
Figure 2: Pirbright site drainage system

Figure 2 shows a schematic view of the main site drainage system, which exhibits the following characteristics:

- The foul drainage has been constructed in phases, and comprises of predominantly vitreous clay pipework, with some cast iron and UPVC. Older pipework tends to be 4" (100mm), whilst newer pipework tends to be 6" (150mm).
- IAH and SL waste is discharged via gravity mains, whilst MAH waste is discharged via a sump and a pump main (served by two pumps).
- All waste undergoes secondary treatment at a caustic soda plant (~50 years old). It is then held in storage tanks, until its pH is below 11, before being discharged to the main sewer where it undergoes final treatment at Hockford sewage treatment works.
- Surface water from IAH and SL areas is stored in buried open-topped tanks, with overflows to a small lagoon, and eventually discharged into the Stanford Brook. That from MAH area is discharged directly to the public sewer.

The drainage surveys identified that, of the many areas of concern, the section between manholes FM1 and F7 (see Figure 2) was the critical section; this portion of the system exhibited many different defects and also conveyed the greatest discharge. Within this section, manhole FM1 was highlighted to be of particular concern as it was:

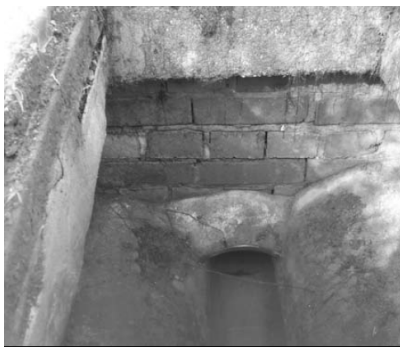
a. Damaged manhole joints

Figure 3: Examples of drainage system defects (source: HSE report³)

- General structure not well understood.
- Poorly fitting manhole covers and damaged chambers (see Figure 3a).
- Cracks and displaced joints (see Figure 3b).
- Debris accumulation and tree root ingress.
- Evidence of water ingress at pipe crowns.
- Permanent standing water in some sections.
- Dead legs associated with decommissioned facilities.
- Evidence of repeated blockage and surcharging.
- Number of recent breakdowns of final treatment plant (e.g. valve failure).
- Evidence that foul flows have entered surface water lagoon.
- Unsatisfactory maintenance/inspection procedures, including no routine testing of discharges.

- Improvements to the site drainage system to ensure full containment (infrastructure, maintenance, monitoring, records).
 - Pending construction of a new system, existing pipework has been relined, manhole covers sealed and dead legs blocked off to ensure containment.
 - In the interim, all FMDV waste must be completely inactivated prior to discharge.
- Improved waste treatment procedures to minimise discharge of live FMDV to site drainage system.
- Improved clarity of biosecurity regulations and responsibilities.

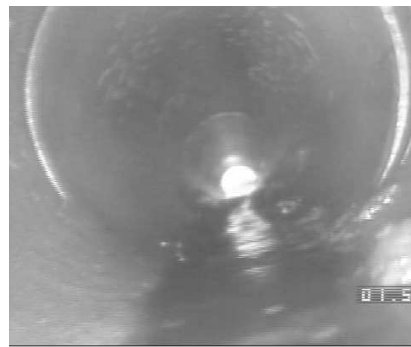
b. Joint misalignment and crack
