## Case study: Drainage and foot-and-mouth

Proceedings of The 34th International Symposium on CIB W062 Water Supply and Drainage for Buildings

# Case study: drainage and foot-and-mouth

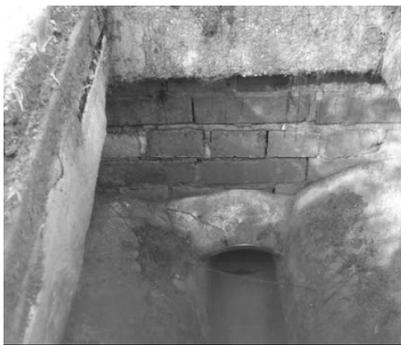
- General structure not well understood.
- Poorly fitting manhole covers and damaged chambers (see Figure 3a).
- Cracks and displaced joints (see Figure 3b).
- Debris accumulation and tree root ingress.
- Evidence of water ingress at pipe crowns.
- Permanent standing water in some sections.
- Dead legs associated with decommissioned facilities.
- Evidence of repeated blockage and surcharging.
- Number of recent breakdowns of final treatment plant (e.g. valve failure).
- Evidence that foul flows have entered surface water lagoon.
- Unsatisfactory maintenance/inspection procedures, including no routine testing of discharges.

a. Damaged manhole joints

- Improvements to the site drainage system to ensure full containment (infrastructure, maintenance, monitoring, records).
  - Pending construction of a new system, existing pipework has been relined, manhole covers sealed and dead legs blocked off to ensure containment.
  - In the interim, all FMDV waste must be completely inactivated prior to discharge.
- Improved waste treatment procedures to minimise discharge of live FMDV to site drainage system.
- Improved clarity of biosecurity regulations and responsibilities.

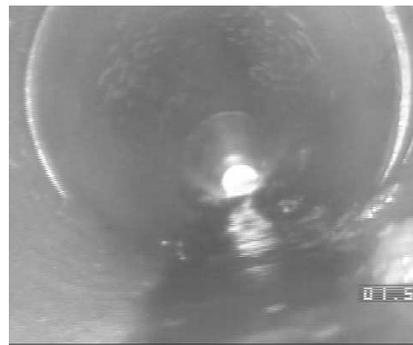
b. Joint misalignment and crack
