## Ethanol driven building fungus colonisation: 'Whisky Black' in urban built environments

Craig, N, Pilcher, N, Forster, AM & Kennedy, CJ 2023, 'Ethanol driven building fungus colonisation: 'Whisky Black' in urban built environments', *International Journal of Building Pathology and Adaptation*, vol. 41, no. 1, pp. 238-257. <https://doi.org/10.1108/IJBPA-05-2021-0079>

# Ethanol driven building fungus colonisation: 'Whisky Black' in urban built environments

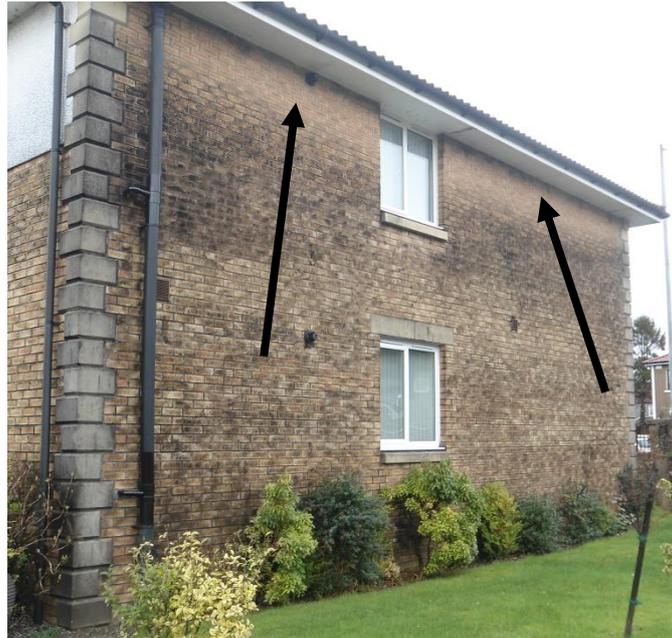
During the visual inspections of the fifty properties some additional observations were made with regard to particular elevations. On the majority of elevations there were areas on which the Whisky fungus was not evident or not evident to the same extent as the rest of the elevation. The areas where the Whisky fungus was not as evident was found to be under the eaves of the roof of the property, or under projecting window cills. Areas sheltered by the eaves varied in size, extending to approximately one metre beneath the eaves on some properties. Areas protected by projecting cills were smaller in size and reached approximately 0.3m beneath the projection. Figure 9 shows the areas beneath the eaves (shown by the black arrows on Figure 9 and the white arrows on Figure 10) and the window cills having a lesser extent of Whisky fungus growth than the remainder of the external wall and therefore the 'soiling' not being uniform across the surface. Figure 10 demonstrates the manifestation of the black fungus on a heavier scale with areas beneath the eaves again not uniform in coverage and also the exterior wall of the integrated garage which had been cleaned of the Whisky fungus. Areas sheltered by eaves and projecting cills will also be protected from rainwater, whereas the rest of the building envelope will be exposed to rainwater. Therefore, this confirms that the Whisky fungus prefers damp climates and requires some degree of moisture in order to grow.

**Figure 9:** Heavy-Medium elevation demonstrating lack of growth beneath the eaves.

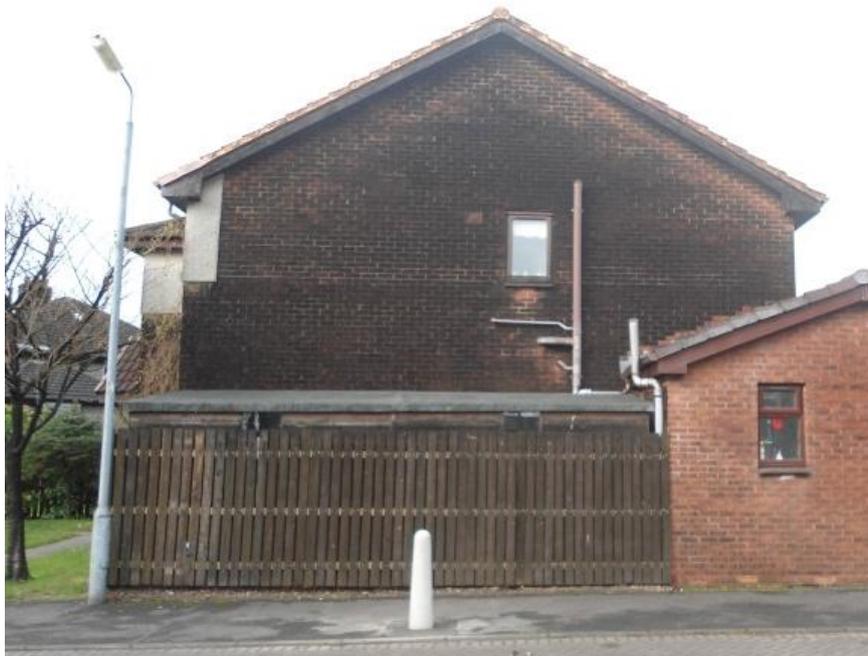
**Figure 10:** Elevation with very heavy growth demonstrating non-uniformity of growth beneath the eaves.
