# Asset Integrity Monitoring of Wind Turbine Blades with Non-Destructive Radar Sensing

**Abstract**— Global growth in onshore and offshore wind energy has created a forecasted 11.5% Compound Annual Growth Rate (CAGR) increase in Wind Turbine (WT) blades throughout 2020-2025. The ability to verify blade condition throughout the asset lifecycle is integral to economic and reliable renewable energy supplies. Currently, commercial inspection of deployed wind turbine blades is predominately performed by rope access personnel using visual and infrared cameras. In this paper we present the results of Frequency Modulated Continuous Wave (FMCW) radar analysis of a decommissioned wind turbine blade exhibiting clearly defined defects. We show that FMCW sensing provides a non-invasive, non-destructive and non-contact means of surface and sub-surface integrity evaluation of these composite structures. We observe absolute unit (a.u.) order of magnitude contrasts for healthy blades at  $0.47 \times 10^6$  (a.u.) versus defective blade structures at  $1.9 \times 10^5$  (a.u.). Our results present the analysis of the decoupled reflected electromagnetic wave, verifying FMCW sensitivity to different

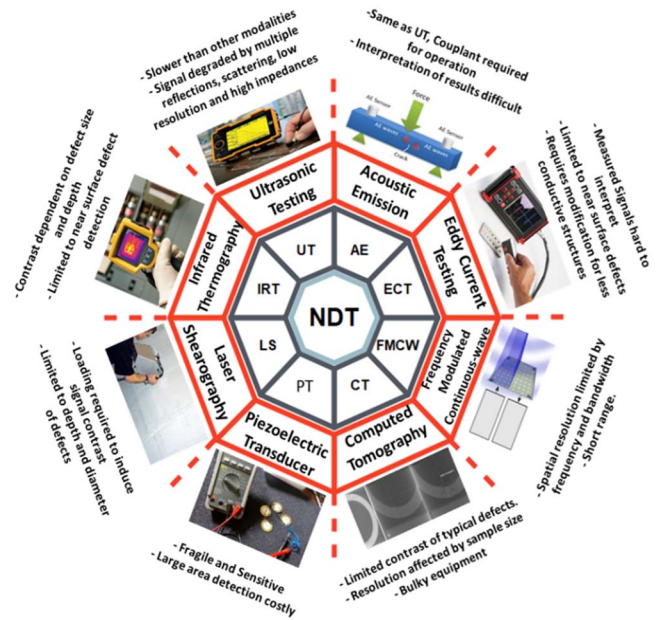
Fig. 1 Graphical summary of various existing methods of composites NDT with their major associated limitations

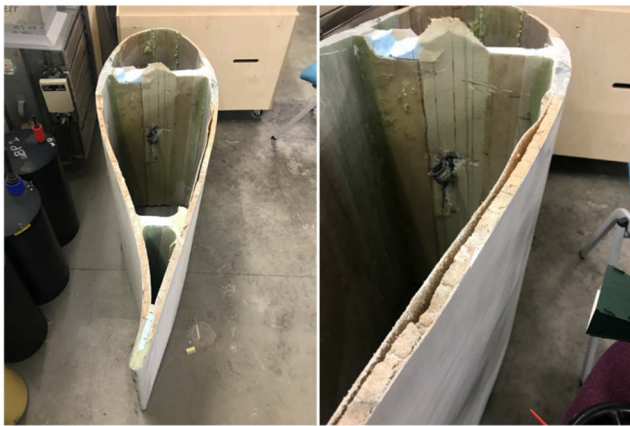
Fig. 3 Sample of defective wind turbine blade showing type 4 delamination detail and area used for the ingress of water during testing. K-band FMCW antenna visible 10 cm to right of structure. Note: delamination situated at internal blade structure and not visible from blade exterior

The antenna was positioned so that the direction of EM propagation was perpendicular to the blade interface as shown in Fig. 3. For experiment A, a healthy section of the blade was scanned to establish a baseline measurement. The radar was then positioned adjacent to a section of delaminated blade structure. For experiment B, the procedure for experiment A was repeated, where FMCW data was continuously acquired for the delaminated area. A contrast agent of 3 ml of water was deposited within the delamination defect and within the field of view of the sensor. The results from these tests are shown in Section V.

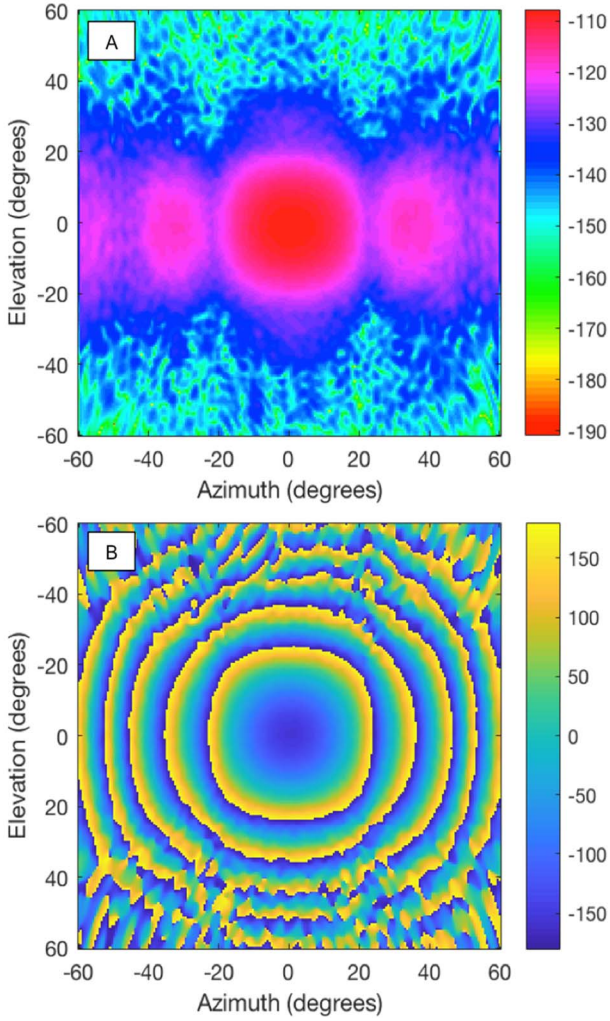
Fig. 5 A) 2D K-Band radiation pattern for amplitude for Flann Microwave antenna model #21240-20 (scale bar in dBm). B) 2D K-Band radiation pattern for phase shift for Flann Microwave antenna model #21240-20 (scale bar in degrees) [21]

To obtain a profile of the radiative output of a Flann K-band antenna model: #21240-20/serial: #219405, a vector network analyser (VNA) output was configured to emit a K-band, frequency-swept signal, while connected to the antenna via a high-frequency Pasternack coaxial waveguide. A two-dimensional translation stage was used to perform three scans coupled to a WR42 type OEWG (open-ended waveguide) standard probe for the K-band (18-26.5 GHz), and using a non-radiative near-field separation distance between the probe and the antenna of 100 mm. Data sets were acquired to represent the 1500 MHz bandwidth sweep used in the radar module. Fig. 5A shows the 2D radiation pattern acquired. Fig. 5B illustrates the phase shift characteristic of the same antenna - VNA configuration.

The purpose of this characterization work was to quantify the sample area on the target. This was determined as being within a consistent radius, if all work was conducted at a fixed sample - antenna distance of 100 mm. The Flann microwave antenna was shown to display a radiation pattern dispersal characteristic with a peak amplitude representing a spot size on the target of  $\sim 36.4$  mm radius at a separation of 100 mm with a minimal phase differential and representing the effective field of view of the sensor.

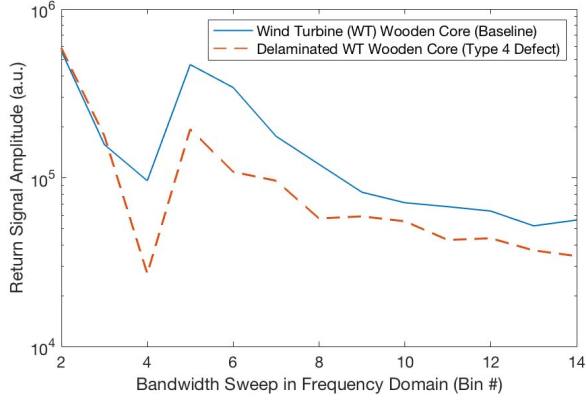
Fig. 7 Comparison of return signal amplitudes in the frequency domain for a healthy section of wind turbine blade wooden core structure versus a section of wooden core exhibiting a type 4 defect (see Table 1 and Fig. 3)

This section presents baseline tests to assess the sensitivity of K-band FMCW to contrasts in wind turbine blade structure integrity. Fig. 7 shows the difference in RSA for a wooden core section of wind turbine blade with no defects and a section of wooden core of similar parameters of composite structure and thickness but exhibiting type 4 defect damage, as fully described in Table 1 and shown in Fig. 3. The healthy baseline measurement shows a peak at bin 5, corresponding to a distance from the sensor of 100 mm, of RSA  $0.47 \times 10^6$  (a.u.),

with a type 4 defect giving an RSA of  $1.94 \times 10^5$  (a.u.). This significant contrast in RSA validates the use of K-band FMCW to discriminate between healthy and defective sections of wind turbine core structures. This contrast is visible at both the primary interface at bin 5 and in the delayed returns between bin 5 and bin 14+. These delayed returns give valuable data regarding the pore contents in porous composite materials and represent the many interfaces present within a porous composite structure. Section VB will present results acquired for small volume fluid ingress within the same delamination feature.

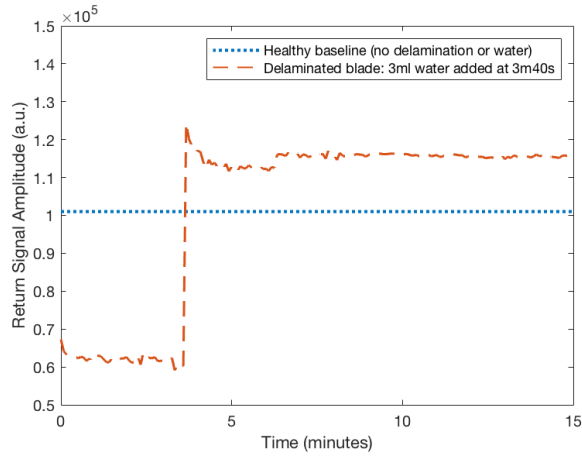
Fig. 8 Dynamic return signal amplitude of water ingress to an area of internal delamination within a wind turbine blade structure. Water added to type 4 defect at 3 mins and 40 seconds into experiment

The results for water ingress within a type 4 delaminated wind turbine blade structure are illustrated within Fig. 8. For this test, the data shown represent dynamic conditions at bin 7, an area beyond the first interface observed at bin 5 in Fig. 7 and thus representative of a bulk volume of the internal structure of the wind turbine composite laminate skin structure. From this data, the following is observed:

- The RSA of a healthy baseline (undamaged) area of the turbine blade structure is approximately  $1.0 \times 10^5$  (a.u.) (i.e. low dielectric of constant thickness and as expected for a structure made of porous polymers reinforced by layered carbon fiber and glass resins).
- The RSA of the damaged, delaminated area of turbine blade structure ranges between  $0.65$  and  $0.7 \times 10^5$  (a.u.) (i.e. lower dielectric than the healthy baseline value due to increased porosity and inconsistent thickness).
- The addition of 3 ml of water into the delamination at 3 minutes and 40 seconds, while obscured from the sensor by  $\sim 2$  cm of porous polymer and retained by the inner carbon fiber/glass resin layer, results in a clear and immediate contrast in RSA that is significant and distinct from the healthy baseline.
