Biofilms on porous building materials: friend or foe?

9th International Conference on Durability of Building Materials and Components

Biofilms On Porous Building Materials: Friend Or Foe?

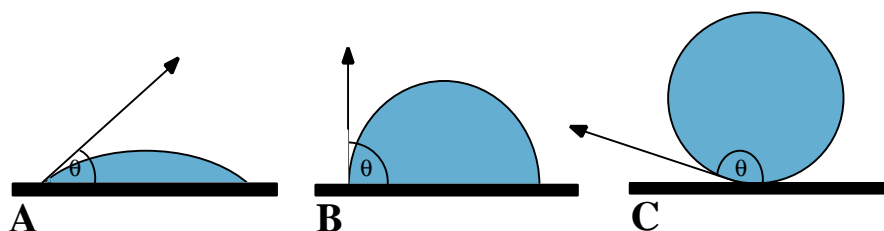
Figure 1. Contact angles of water droplets, measured in a water vapour atmosphere, on a solid surface (e.g. quartz and biofilm). A) Low contact angle ($< 90^\circ$), forming on an hydrophilic surface. B) Intermediate contact angle ($\sim 90^\circ$), forming on a surface of intermediate wetness (neither hydrophilic nor hydrophobic). C) High contact angle ($> 90^\circ$), forming on an hydrophobic surface.

The water phase wettability of a biofilm is an important factor effecting water placement and movement within porous building materials. Wettability describes the relative affinity of a fluid for a substrate (Walker 1999), and determines whether a fluid such as water will spread out across a substrate or be repelled and form discrete droplets. The degree of wettability is commonly measured by the contact angle that a droplet of fluid forms on a solid (Bascom 1992, Schoff 1992, Xie & Morrow 1998, Liu & Buckley 1999). In the case of water, when measured through the densest fluid phase, in this case the water itself, a low contact angle will be observed where the substrate is hydrophilic (Fig.1a), the water droplets form low domes, or occur as discrete sheets. Whereas, a high contact angle will occur on hydrophobic surfaces (Fig.1c), where water will occur in the form of discrete spherical droplets. Where a substrate is hydrophilic, it can be said to be water wet, which, under ambient conditions, is the case for most sandstones composed of predominantly quartz and feldspar (Barclay & Worden 2000). Whereas those that are hydrophobic, such as some calcitic limestones are regarded as oleophilic, or oil wet (Barclay & Worden 2000). The wettability of a biofilm will therefore affect the relationship between water and a substrate, either on, or within the porous building stone. Wettability will influence the biofilms ability to retain water, as well as affecting the combined biofilm and rock substrate's permeability, and thereby exert a control upon the location and movement of water within the biofilm-porous building material system. As many potentially damaging processes such as leaching, salt shattering and freeze-thaw shattering depend upon the presence of water, the relative water wettability of a biofilm will have major implications for the durability of porous building materials.

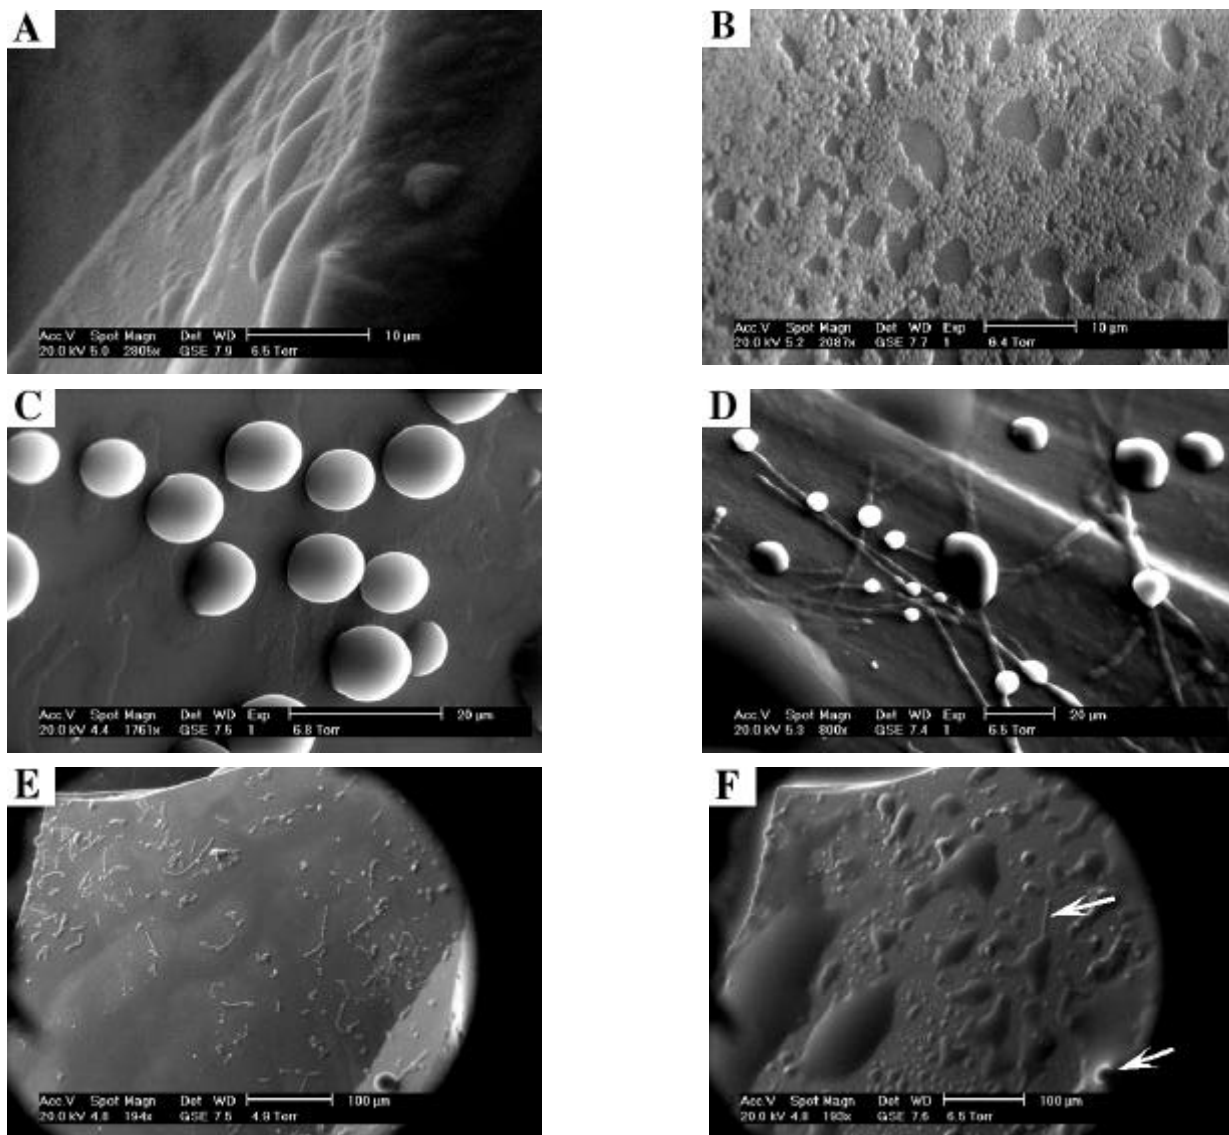
Figure 2. A) Typical wettability of natural quartz surface, showing low domed hydrophilic droplets. B) Bacterial biofilm on quartz. C) High sphericity hydrophobic droplets on bacterial biofilm grown on quartz. D) High sphericity droplets and high domes, on hydrophobic bacterial-fungal biofilm. E) Quartz surface with algal biofilm. F) The same surface as in (E), displaying hydrophilic low domed drops of water. Two areas with algal cells indicated with arrows.

The results of the initial wettability assessment showed that all 30 quartz chips displayed hydrophilic properties and hence their wettability could be described as water wet. Water wetting was typified by low dome droplets displaying contact angles of considerably less than 90° , (Fig. 2a).

The results of the secondary wettability assessment showed that the 10 quartz chips exposed to the bacterial-fungal consortium successfully developed a biofilm (Fig. 2b). The wettability of the quartz chips coated in this biofilm changed from hydrophilic to hydrophobic, typified by high dome droplets with contact angles of $> 90^\circ$, (Figs 2c, d).

The 5 quartz chips exposed to the algal consortium successfully developed biofilms (Fig. 2e). The wettability of the quartz chips coated in algal biofilm remained hydrophilic, indicated by the low dome droplets of water on the algal surface (Fig. 2f).

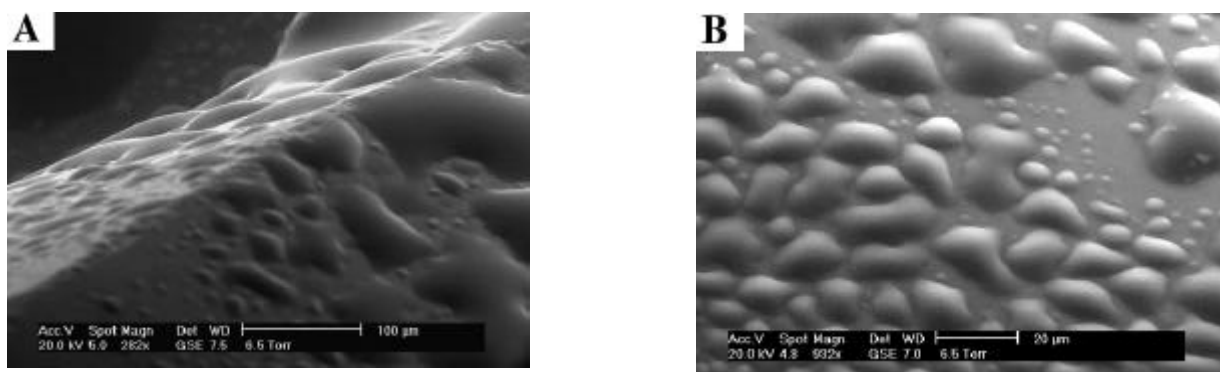
Figure 3. Control samples: A) Quartz control sample from the bacterial-fungal experiment; B) quartz control from the algal experiment. Note both display low domed droplets of water and are hence still hydrophilic

The 15 quartz chips used as controls (i.e. those not exposed to microbes), retained their initial hydrophilic wettability (Figs 3a, b).

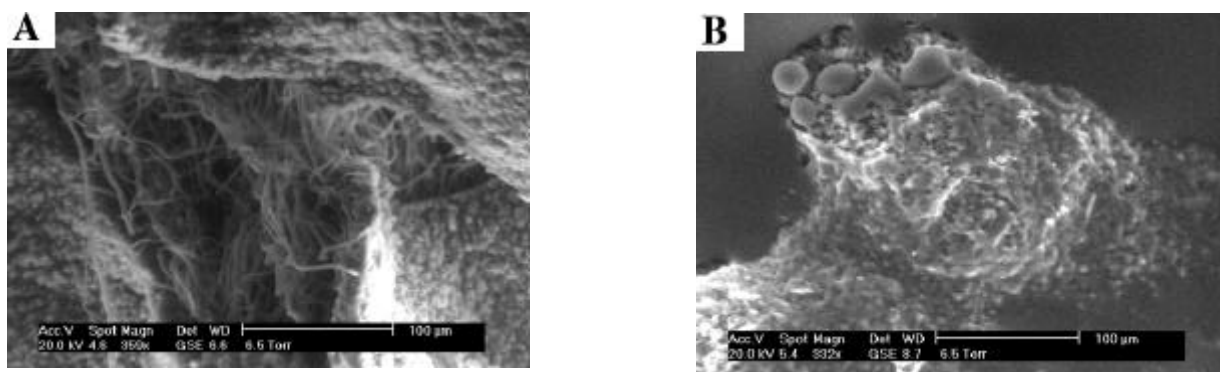
Figure 4. A) Image of Lichen showing typical morphology, of ‘fungal’ hyphae and ‘algal’ cells. B) Typical variation in wettability across lichen. ‘Fungal’ hyphae (top left) are hydrophobic, indicated by spherical droplets of water, while ‘algal’ areas (bottom right) have sheets of water on them, typical of hydrophilic substrates.

The lichen displayed mixed wettability (Fig. 4b).

The sample of lichen that was analysed showed a mixed wettability profile. The portion of the lichen that appeared to be fungal in nature demonstrated hydrophobic tendencies, the portion that appeared to be algal demonstrated hydrophilic tendencies. Given the nature of the biofilm wettabilities outlined above, this was not entirely unexpected.

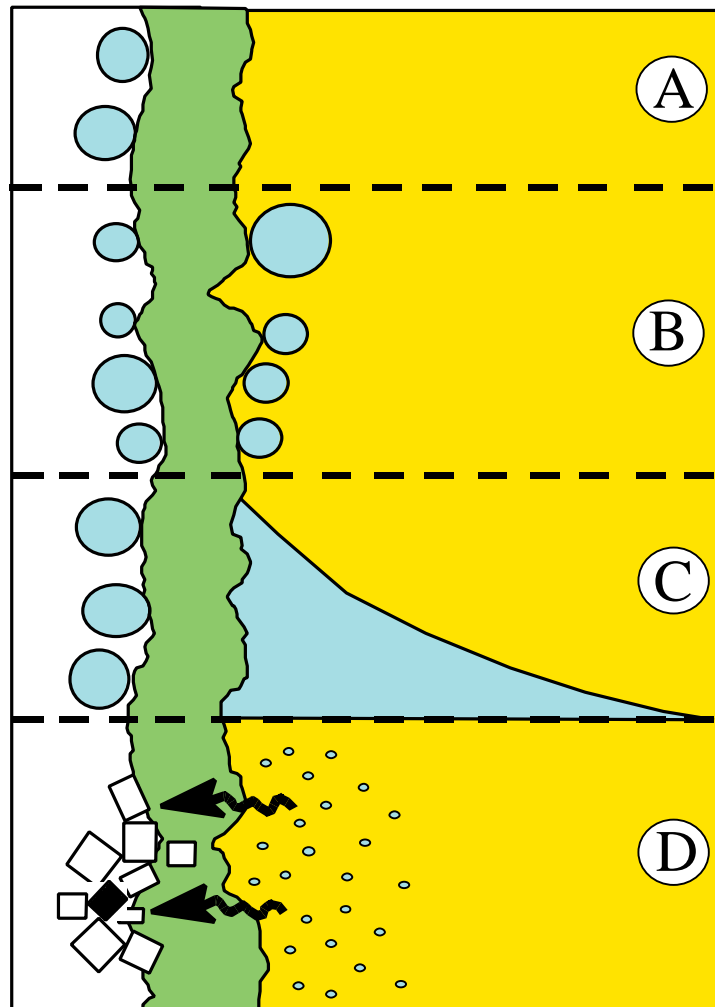
Figure 5. Schematic section through a block of porous building material (sandstone), with a biofilm developed on the outer surface (left hand side). Key: yellow = sandstone, blue = water, green = biofilm. A) Biofilm with hydrophobic external surface. B) Biofilm with hydrophobic external and internal surfaces. C) Biofilm with hydrophobic external surface, and water ponded behind the internal surface. D) Biofilm with high humidity behind the internal surface, and salt crystals forming along the outer surface.

However, if water is able to penetrate the structure from another direction (e.g. ingress from above, capillary rise, or possibly through condensation from within the building), it is equally possible that this water could be retained behind the biofilm (Fig. 5b). This is likely if the adhesive layer of the biofilm is hydrophobic. If this scenario occurred, the build up of water trapped behind the biofilm may accelerate the damage caused by mechanisms such as chemical leaching and frost shattering.

In extreme cases ponding of water could occur within the building stone and once again increase chemical leaching, clay swelling, salt shattering and freeze-thaw shattering (Fig. 5c).

On a more positive note, it is also possible that a hydrophilic biofilm could act as a wick and transport dissolved salts to the surface of the biofilm where they can crystallise harmlessly (Fig. 5d), thus preventing salt shattering and eventual spalling. This has already been noted by Grondona (1997).

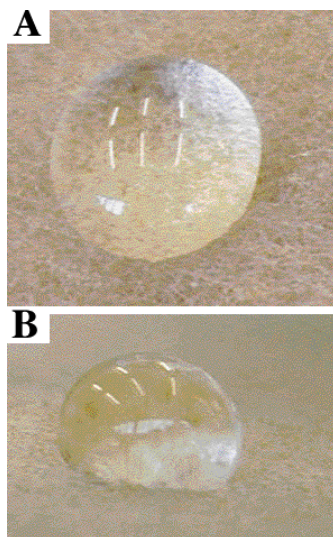
Figure 6. A), B) Plan and side views of water droplets on a block of sandstone with a bacterial-fungal biofilm on the surface. Droplets have a high contact angle, being spherical in form, demonstrating the hydrophobic nature of the biofilm at the macroscopic scale. Droplets are approximately 2-3 mm in diameter.
